Temp-Coat 101 Liquid Ceramic Insulation Coating

Temp-Coat 101 is currently being applied on the Production Test manifold on platform East Kokongo.

Temp-coat 101 Application Process

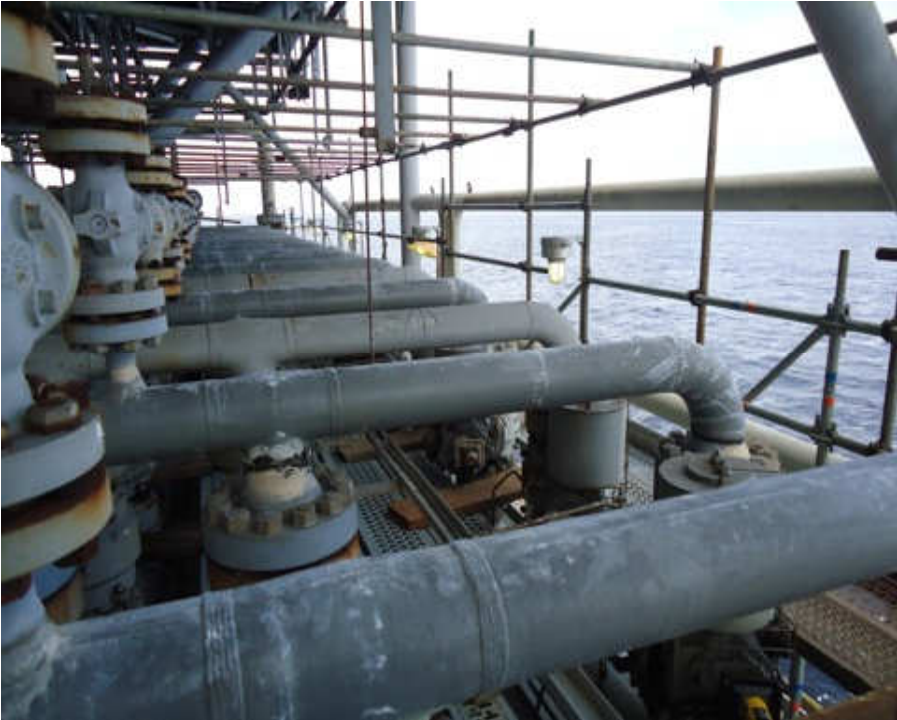
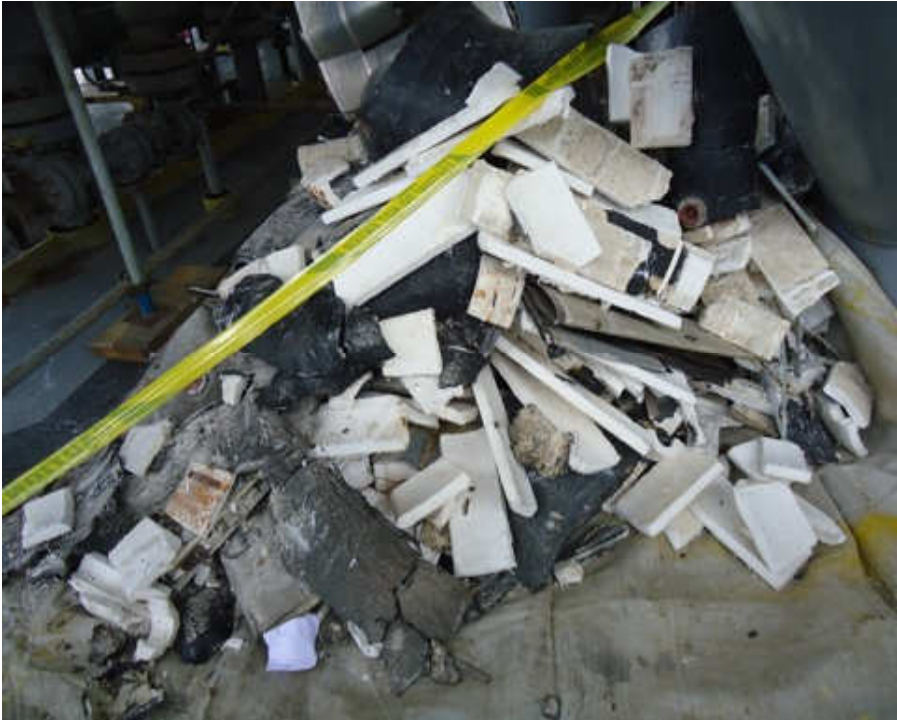
Picture shows where the insulation was removed from the production test manifold.

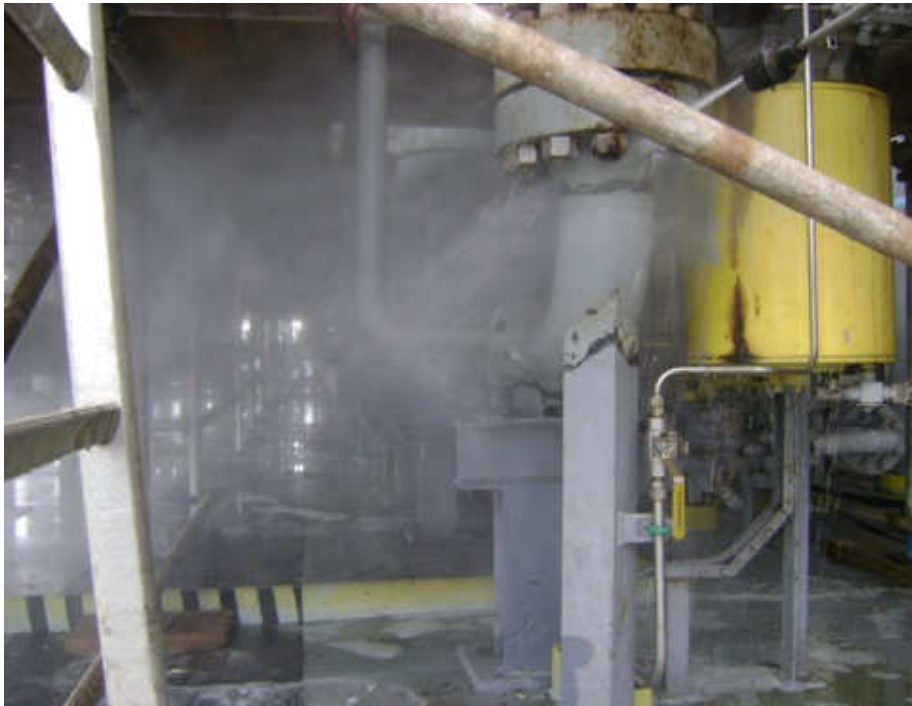
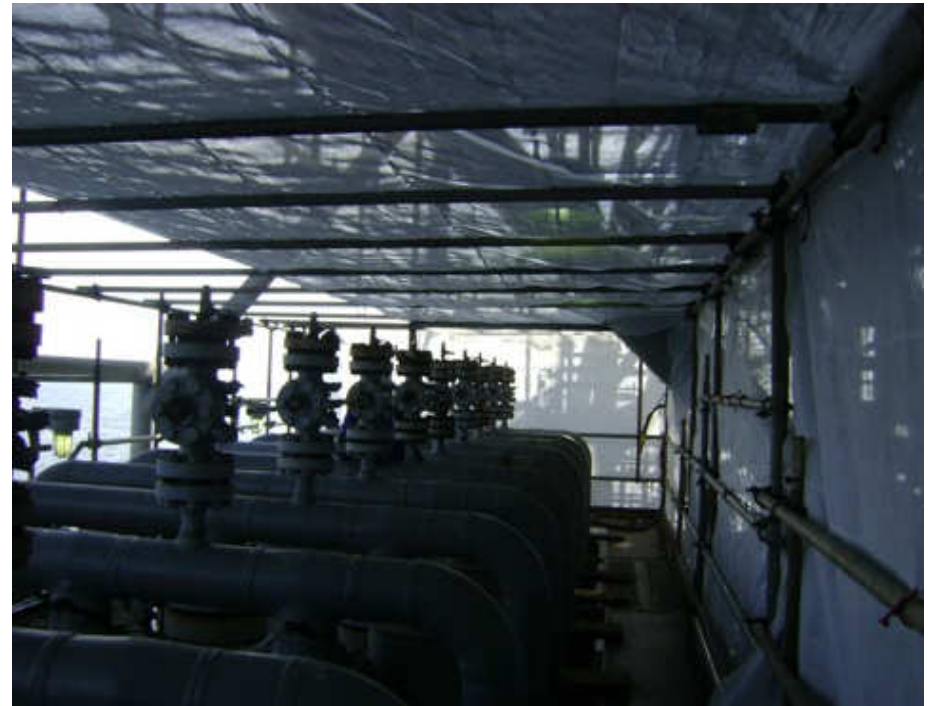
After insulation was removed the manifold is being high pressure water washed and also containing the area with monarflex.

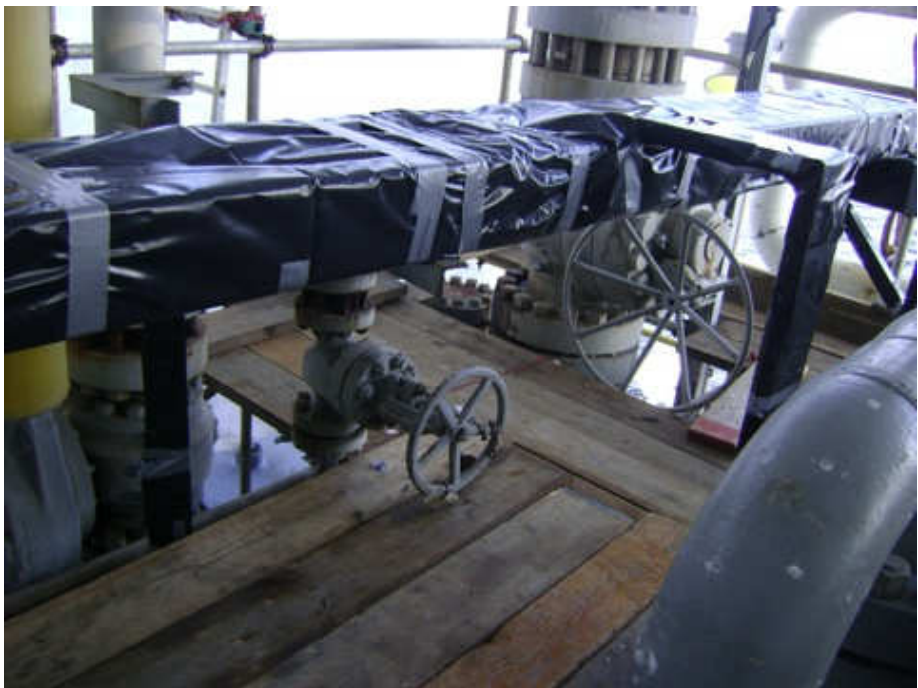
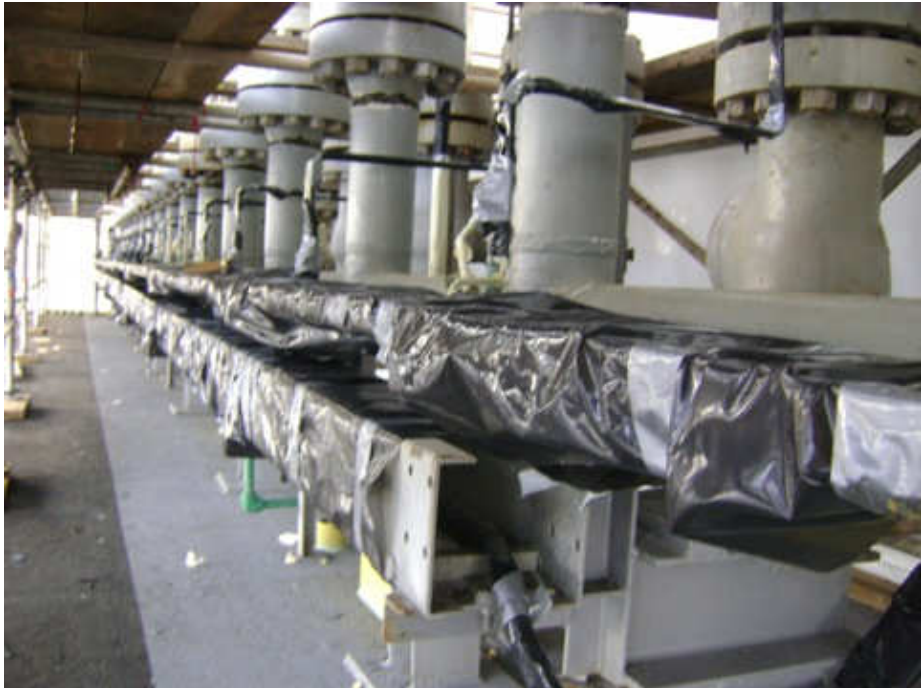
Picture shows where all items are wrapped and protected before the blasting commences to prevent equipment damages.

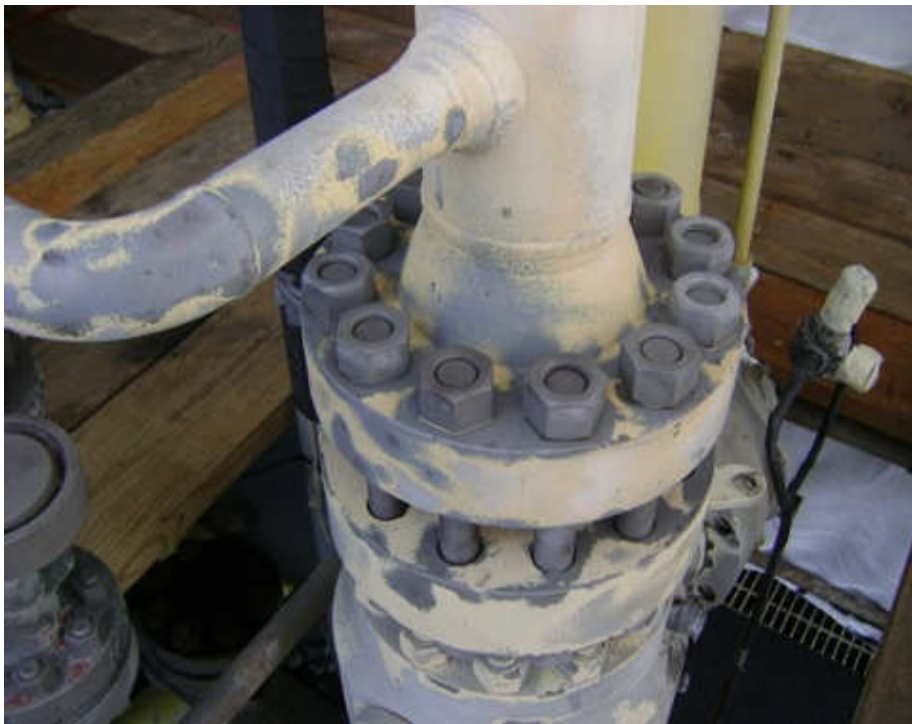
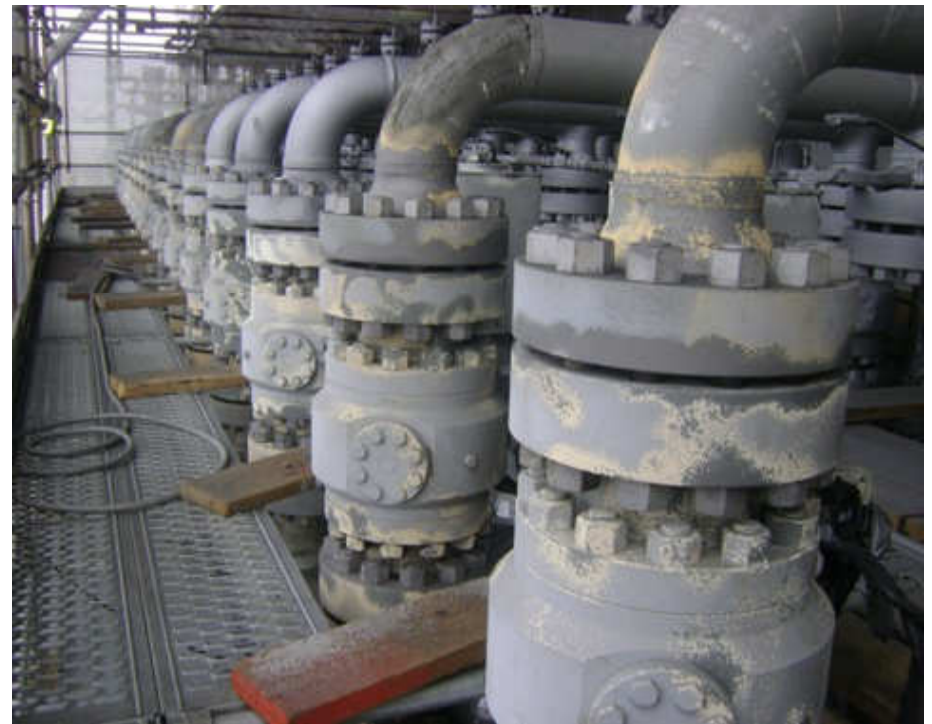
All surface corrosion was removed by dry abrasive blasting

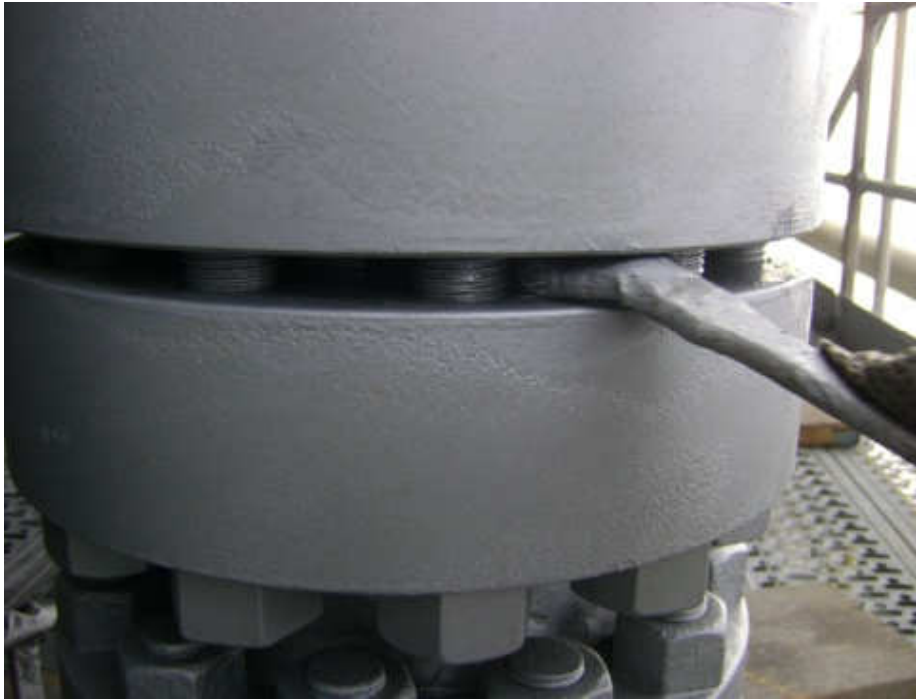
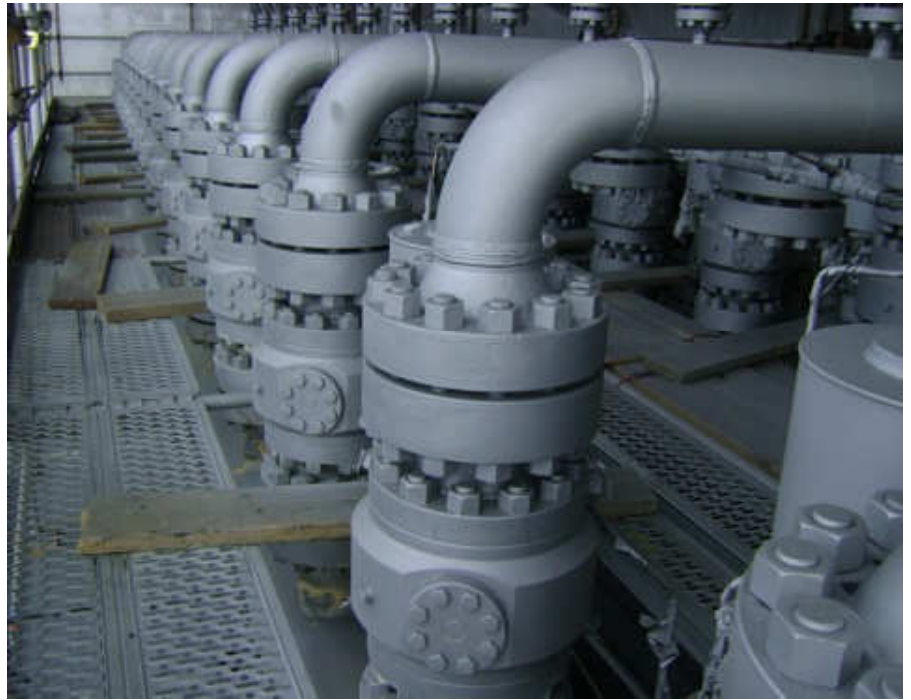
Stripe coating nuts, bolts and hard to reach areas including a full coat of Interplus 256.

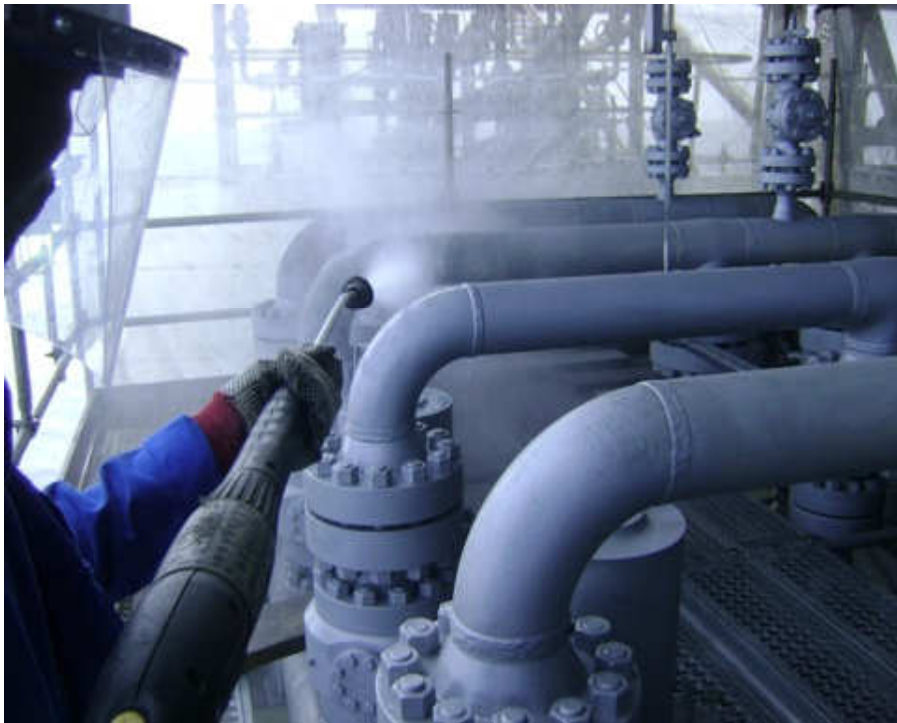
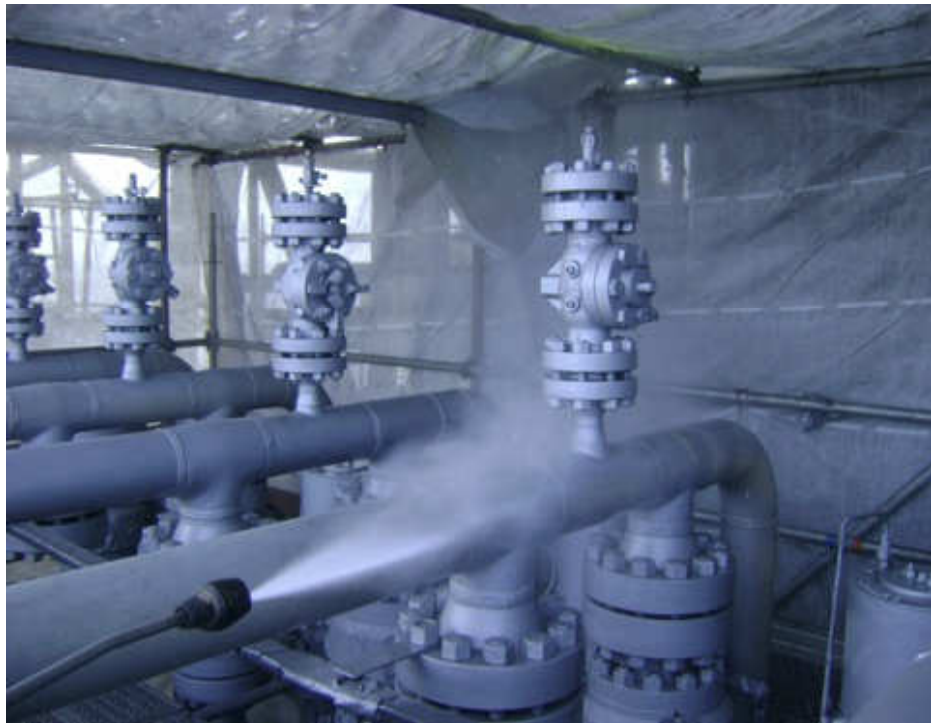
Fresh water washing the manifold after the primer coat application of Interplus 256 to remove any contaminants.

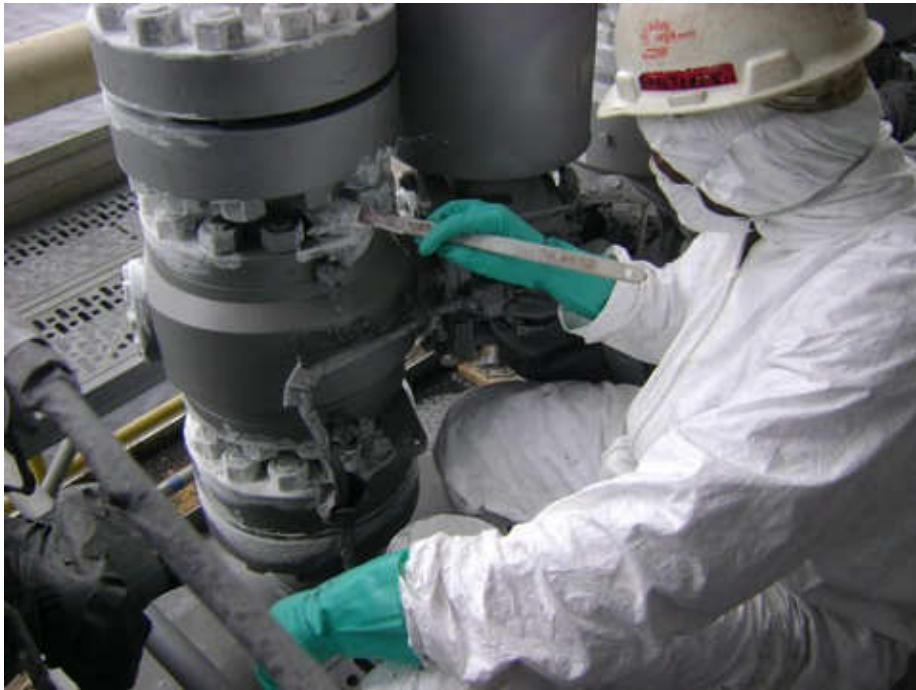
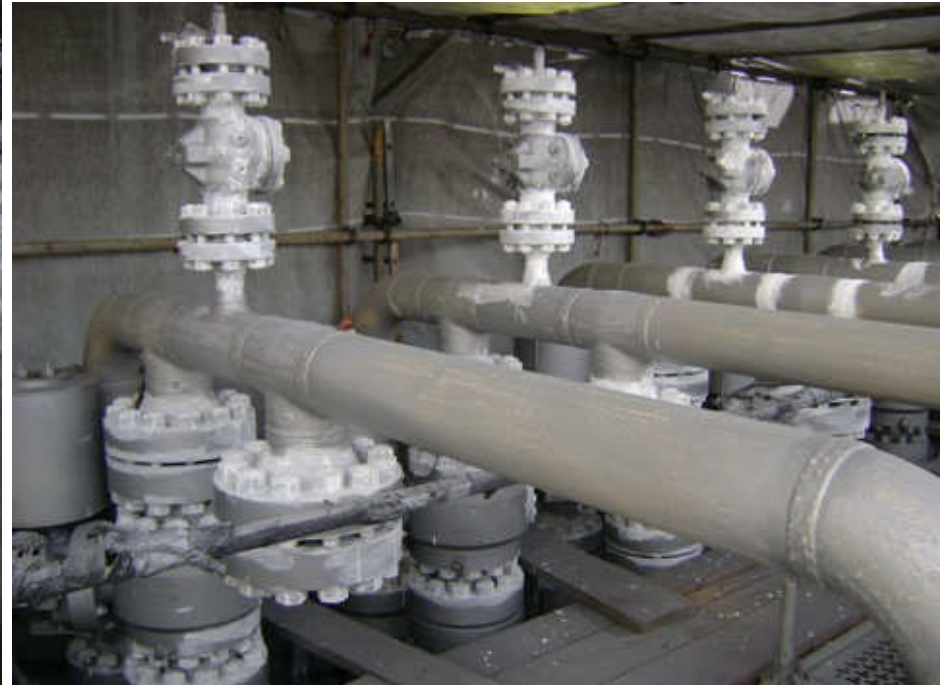
Stripe coating all nuts & bolts, welds and hard to reach areas with Temp-coat 101

Step 1 - stripe coat all welds , nuts & bolts

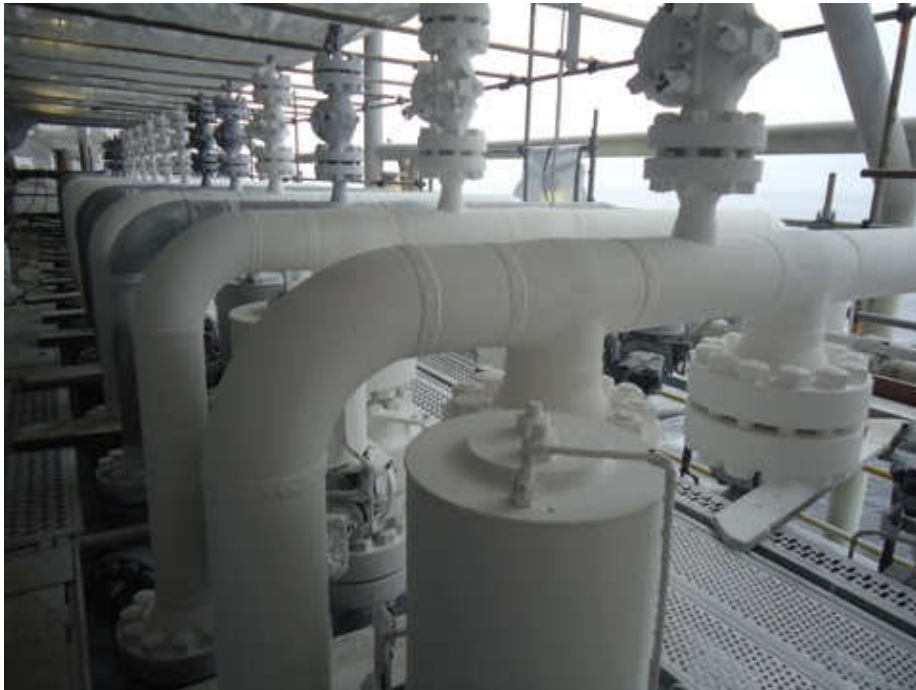
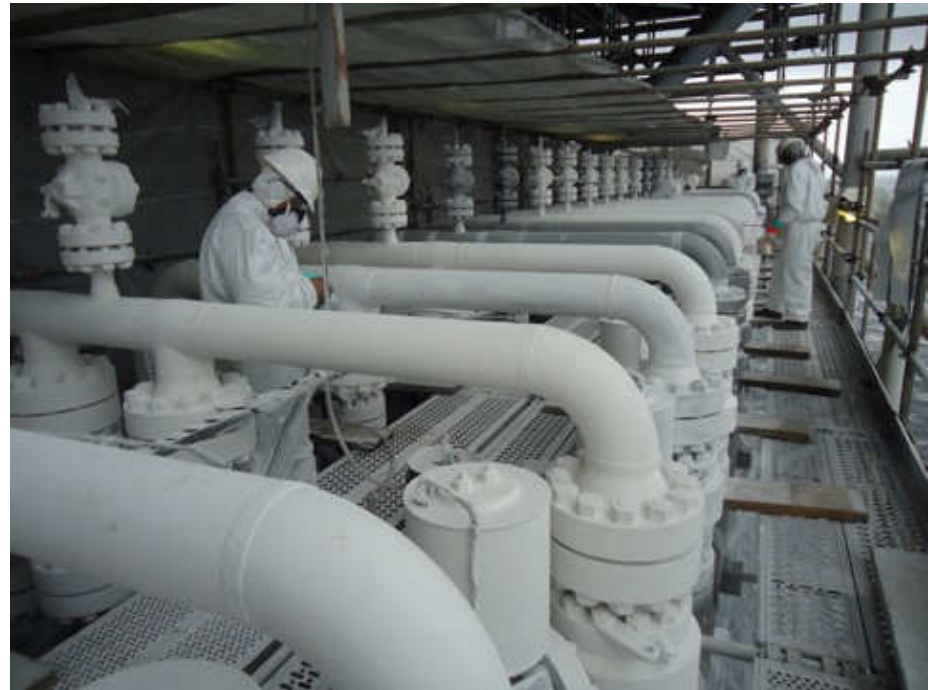
Application of Temp-coat 101 in process

Below are the steps taken for each 6 inch line after the line has been dry abrasive blasted and primed, each coat of temp-coat 101 requires to be dry to touch before subsequent coats can be applied until reaching the total dry film thickness.

Note: If the product is applied thicker than 20 mils the product will blister or crack so its extremely important to follow the manufactures recommendation in order to achieve maximum performance .
