# TECH ALERT

## Mechanical Integrity - Our Plants & Equipment

### Re: Temp-Coat 101

#### A Kick Against Corrosion Under Insulation... Thermal Insulation Coatings Also Come in at Lower Cost

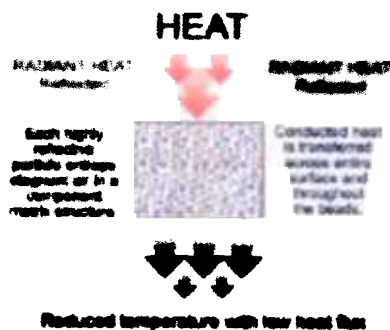
The coating consists of hollow silica and ceramic micro-spheres suspended in acrylic latex binder. Refer to the sketch below.

One of the coating's principal advantages is eliminating conventional insulation, and therefore corrosion under the insulation. Repair, too, is relatively easy because the coating may be sprayed on.

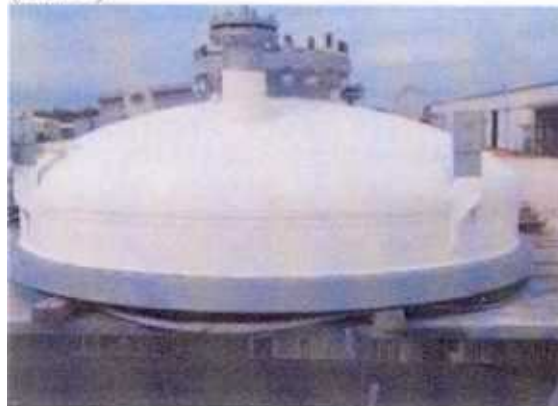
The picture below shows the top head of an LPC reactor on a wagon just after the coating was applied. The head was insulated with hard insulation. During inspection, severe corrosion of the carbon steel under wet insulation was discovered. Metal repairs were made and the head was sandblasted, prime coated, and approximately 125 mils of thermal insulation coating applied. This insulation is for personnel protection and also maintains process temperature stability during rainstorms. It operates around 65°C (150°F).
